**DEPARTMENT OF TRANSPORTATION**

Contract #: 04-0120F4Cty: SF/ALA Rte: 80 PM: 13.2/13.9File #: 69.28**WELDING INSPECTION REPORT****Resident Engineer:**Siegenthaler, Peter**Address:** 333 Burma Road**City:** Oakland, CA 94607**Report No:** WIR-022655**Date Inspected:** 13-Apr-2011**Project Name:** SAS Superstructure**OSM Arrival Time:** 700**Prime Contractor:** American Bridge/Fluor Enterprises, a JV**OSM Departure Time:** 1900**Contractor:** Zhenhua Port Machinery Company, Ltd (ZPMC), Changxing Island **Location:** Shanghai, China**CWI Name:** An Qing Xiang**CWI Present:** Yes No**Inspected CWI report:** Yes No N/A**Rod Oven in Use:** Yes No N/A**Electrode to specification:** Yes No N/A**Weld Procedures Followed:** Yes No N/A**Qualified Welders:** Yes No N/A**Verified Joint Fit-up:** Yes No N/A**Approved Drawings:** Yes No N/A**Approved WPS:** Yes No N/A**Delayed / Cancelled:** Yes No N/A**Bridge No:** 34-0006**Component:** OBG**Summary of Items Observed:**

## WELDING INSPECTION REPORT

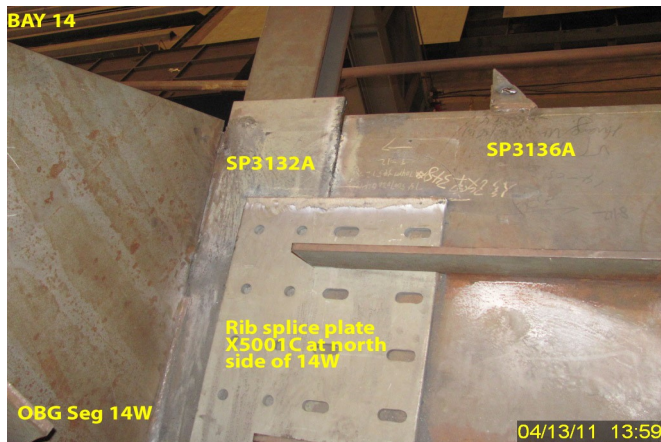
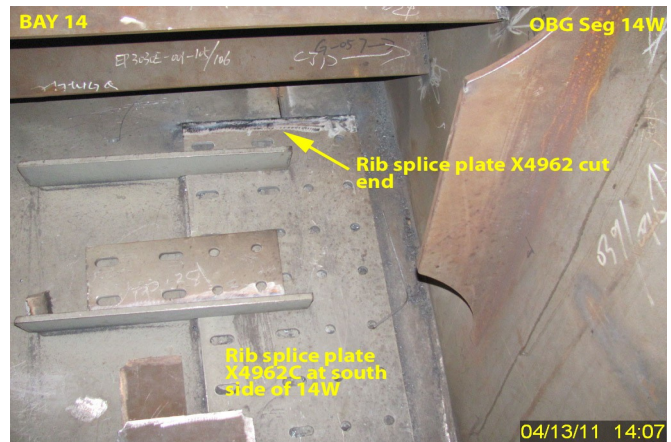
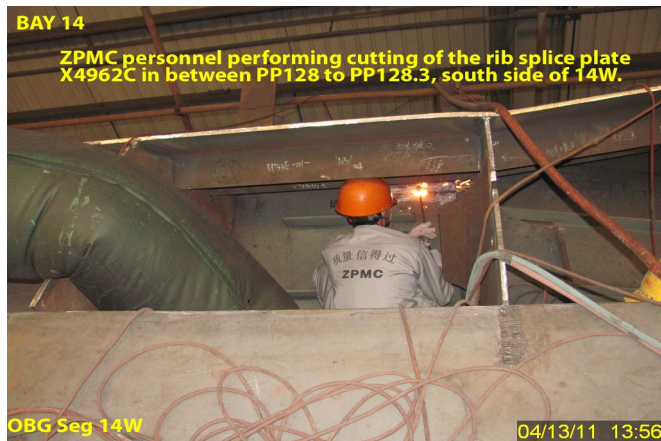
During random in process visual inspection this QA Inspector observed that ZPMC personnel were cutting the rib splice plate X4962C at south side and X5001C at north side of segment 14W. These plates were conflict between the weld joints of side panel to edge panel at PP128 to PP128.3. This cutting has been done with prior approval of engineer. Attached photograph provide additional details.
